Camera background

Test description

Test results

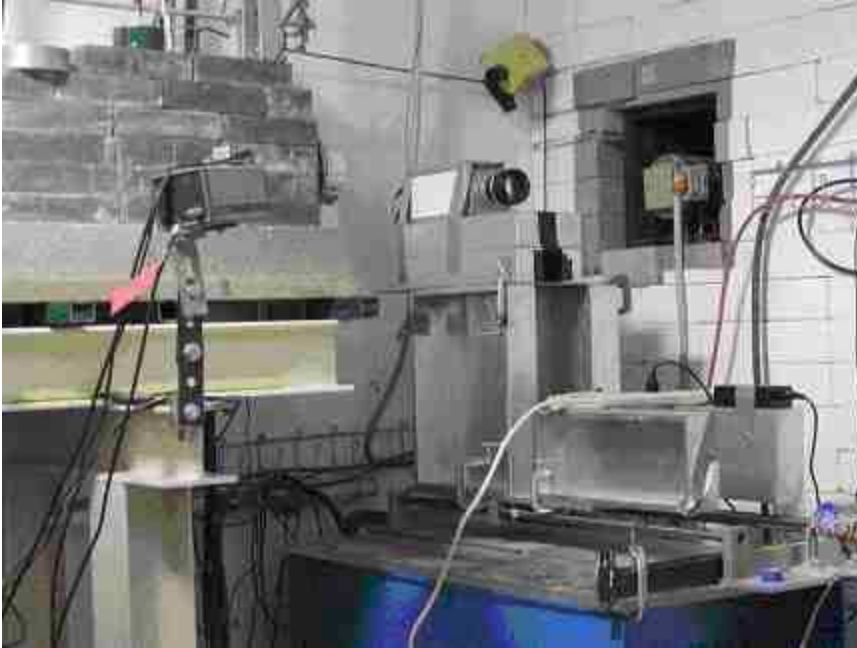
The camera was mounted as shown in the Indiana University Cyclotron Facility. Their Radiation Effects Research Program, RERP, makes available proton and other light ion beams to industry, university and government users for simulation of the space radiation environment, studies of single event and other radiation effects in microelectronic devices and investigations of nuclear radiation effects on optical sensors, opto-electronic and other radiation sensitive components.

The plan was to use the camera in a typical operation while radiating the electronics components from the camera's side with the beam with a level equivalent to a 10 year dose of heavy particles. Beam shape was 2 inch x 2.25 inch after passing through a copper vignette and the beam was expected to be pointed at an array of six side locations (a grid of three horizontal locations by two vertical locations) in addition to the location of the CMOS sensor. Only the first three positions were radiated before the tests were stopped due to the camera failure to communicate with its control laptop (located in the control room).

This specific test camera (supplied by Vision Research) was tested last November in the University of Indiana's radiation facility in Bloomington, Indiana. Standard JSC program testing (simulated 10 year operation) was done. After Vision Research received the radiated Phantom v5 back from Indiana, they performed a careful autopsy to determine what failed. They noted that the Phantom v5's firmware resides in a toshiba flash chip on the timing board (which is in the middle of the stack of boards) and that the firmware is loaded into a fpga thru a microprocessor when the camera boots. The camera died while it was operating, which would infer that the fpga lost all or part of its programming. The fact that we could not reboot the camera implies that the toshiba flash chip (which holds the firmware) lost all or part of its program. After the autopsy, the firmware was reloaded into the toshiba flash chip and the camera functioned properly. The workaround, assuming that we control the v4 or v5 via an RS232 serial link, would be to write a c+ routine to accomplish this. The firmware for both the v4 and v5 is loaded by the serial link, and there are supposedly three programming "steps" involved in order to reload the camera's firmware. Two of the steps involve using a "programming jumper" (installed at the 10 pin connector on the rear of the v5) or a "programming switch" (accessible under the rear cover of the v4).
